| NAMEPLATE DATA | | |

| Motor Model: | BR3-CI-TF-444TC-6-RR-E-100 |

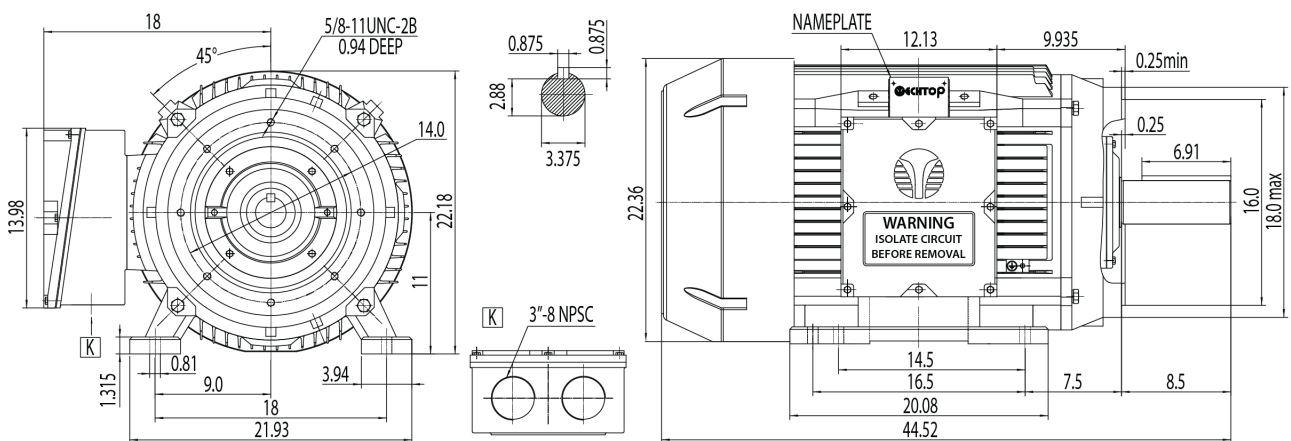
Dimensional Drawing

Dimensions are for reference only. Allowance should be made for minor deviations in non standard specified properties.
